SERVICE BULLETIN

DATE: 1-Aug-02 BULLETIN NUMBER: 235 Update (pg. 1)

SUBJECT: Cam Shaft Drive Tang Reinforcing Sleeve

MODEL AFFECTED: Universal M 25XPB, M 25XPBC, M 35B, M 35BC

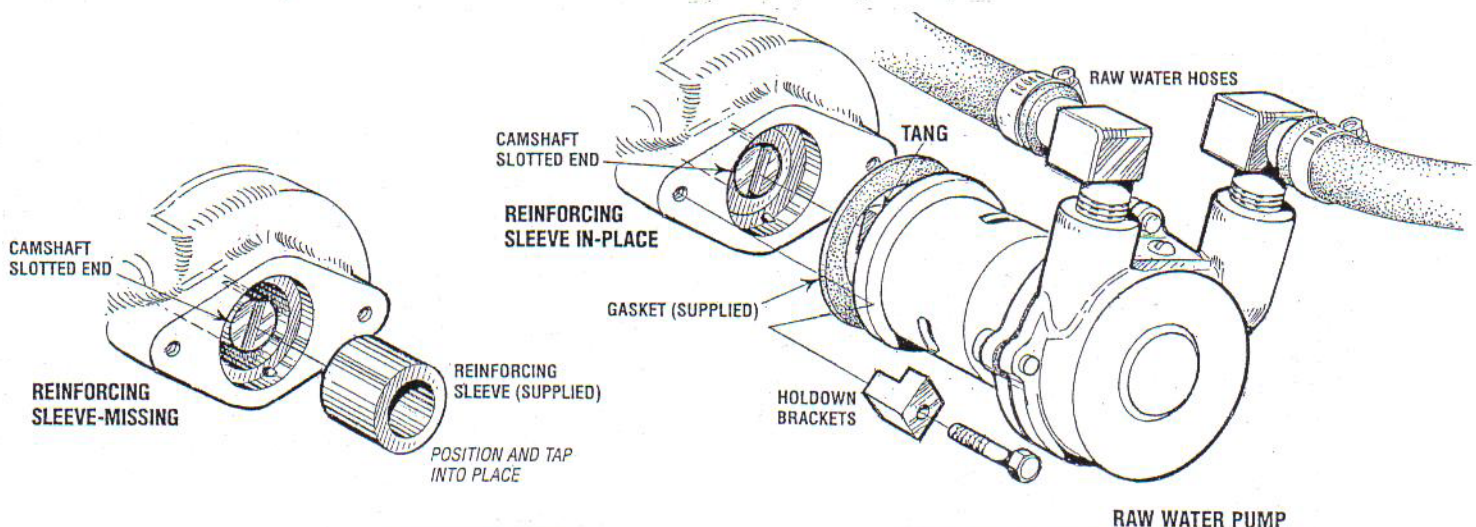
Random reports have been received from the field related to the failure of the sea water pump drive tang on the cam shafts of early Model "B" Series *UNIVERSALS* listed above.

These failures are related to early production models and it has been found that the sea water pump drive tang reinforcing sleeve had not been installed.

Owner/operators are advised to immediately remove the sea water pump off the front gear case of their engine and inspect the cam shaft sea water pump drive end to make sure it has this reinforcing sleeve. The illustrations show the cam shaft end with and without the reinforcing sleeve.

The reinforcing sleeve is easily installed as it is just a slight force fit fully over the sea water pump drive end of the cam shaft. Position the reinforcing sleeve squarely onto the end of the cam shaft and gently tap/push it fully onto the shaft end so it is flush with the end of the shaft.

Reinstall the sea water pump using the replacement mounting gasket supplied with the reinforcing sleeve.
